# C-130 Oil Cooler Door Actuator

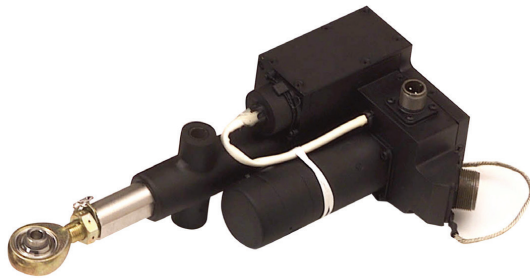
Legacy oil cooler door actuators continue to be a source of problems for the US Air Force C-130 fleet. The problem stems from premature failures in legacy manufactured actuators.

**The Solution:** Replace the legacy actuator with the new upgraded CEF oil cooler door actuator:

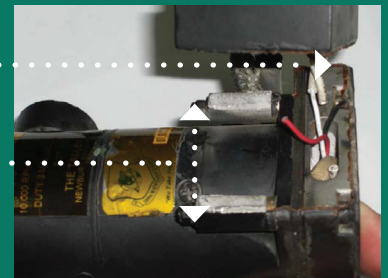
### BROKEN WIRES

### TWO BROKEN WELDS

- The results of tear downs indicated that there were problems in the wiring, filter and connector that could be corrected by process changes in overhaul.
- Currently no data on improved reliability of legacy actuators.
