C-130 Oil Cooler Door Actuator

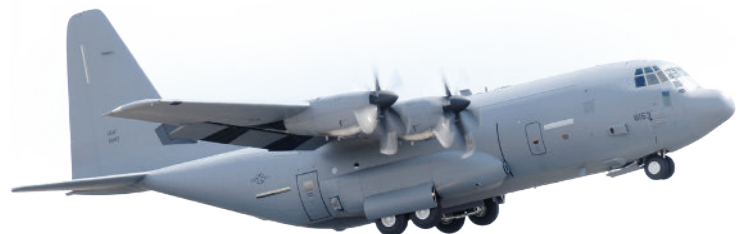
BROKEN WIRES

TWO BROKEN WELDS

- The results of tear downs indicated that there were problems in the wiring, filter and connector that could be corrected by process changes in overhaul.
- Currently no data on improved reliability of legacy actuators.

The Solution: Replace the legacy actuator with the new upgraded CEF oil cooler door actuator:
