CN-235 PROPELLER REPLACEMENT NOTICE

Collins (UTAS/Hamilton Sundstrand) manufactures the CN-235 propeller and issued a service bulletin for 14RF-21-61-2 and 14RF-21-61-6. These service bulletins advise CN-235 aircraft operators of the program requirements and procedures to be followed for all propellers.

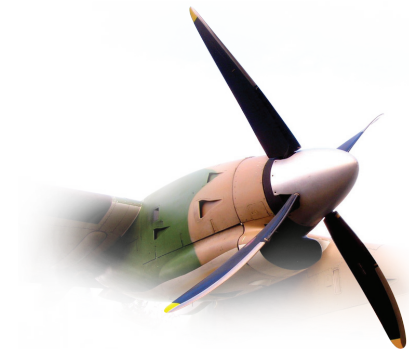
14RF-21
CN-235 CT-7 ENGINE

782750-8 PROPELLER	782750-12 PROPELLER
RFC11L1-OC	RFC11W1-OC
RFC11P1-OC	RFC11Y1-OC
RFC11R1-OC	RFC11Y1P-OC
RFC11V1-OC	RFC11Y1R-OC
RFC11Z1-OC	RFC11Y1POC*
RFC11Z1POC*	*LATEST CONFIGURATION
